In Vitro Study of the Contamination Remaining on Used Healing Abutments after Cleaning and Sterilizing in Dental Practice

Article in *Clinical Implant Dentistry and Related Research* · December 2015

Chandur Wadhvani, BDS, MSD;*† Todd R Schoenbaum, DDS, FACD;‡ Franco Audia, DDS, MS;§¶ Kwok-Hung Chung, DDS, PhD**

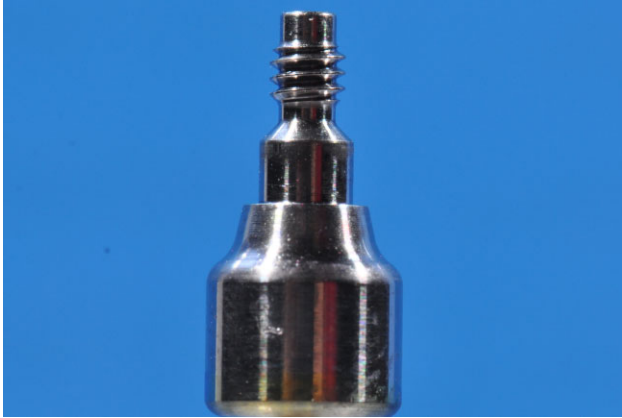
Figure 1 As received specimen, reportedly: Used, wiped, cleaned, and autoclaved.

Representative photographs of the specimens are seen in Figures 1–4. Although it was possible to see contamination with the unaided vision on some of the abutments, many (68/100) appeared to be free of residual contami-

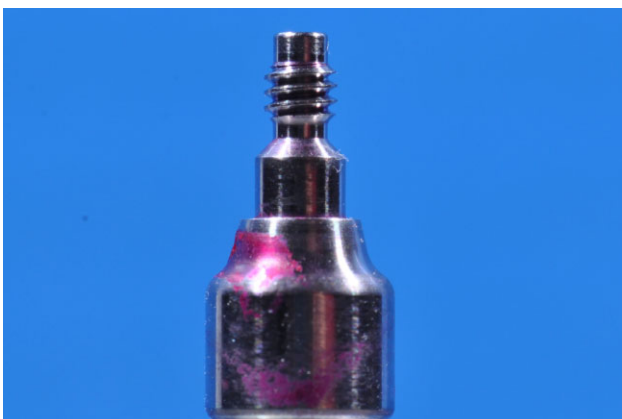
Figure 2 Phloxine B protein and peptide stained. Sites of contamination seen red/orange.

The tapered form of implant abutment (Figures 2 and 5) had a tendency to show contamination at the IAJ, due to the inherent ledge design. Along the body of the abutment, when segmented into thirds (BO, BM, BI), there appeared to be little difference in the percentage of residual contamination sites (61–65%). The screw driver site (D) was contaminated in 90% of specimens (Figure 4). In contrast, none of the control group had any staining when evaluated at any of the sites (Figure 7).

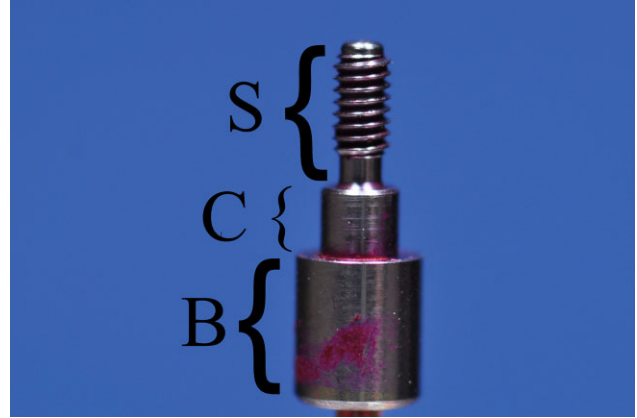
Figure 3 Site evaluation: Body (B) of the abutment represents three sections: implant, mid, occlusal – all showing phloxine B staining and residual contamination. Connection (C) to implant site. Screw (S) thread shank and threads.

Of the 99 HAs showing contamination on at least one site: 92 had contamination on the (S) screw thread or shank of the screw. The implant connection (C) site had contamination on 85/99 of the HAs. Of the 400 body rotation sites recorded, 46 were considered to be clean, with the remainder 354 surfaces showing some form of staining. The location of the contamination and

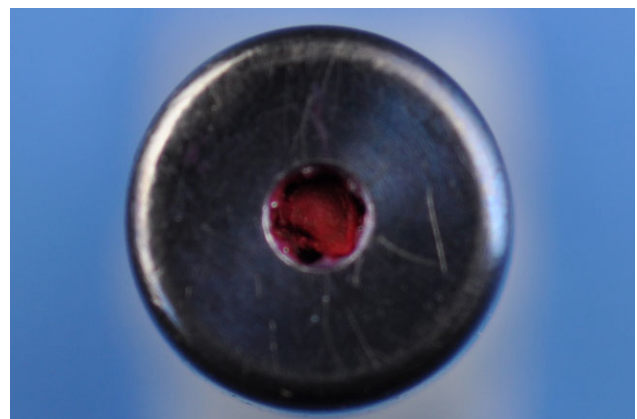
Figure 4 Screw driver (D) engagement site with Phloxine B stain evident.

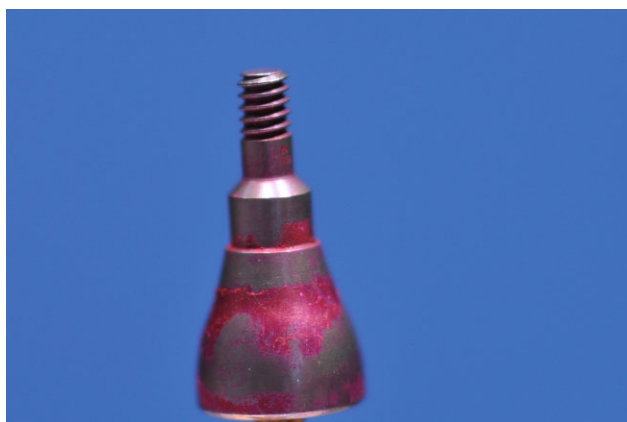
Figure 5 Anodized healing abutment: The phloxine B clearly highlights residual contamination site.

nation. Some of the abutments were color anodized on some or all surfaces which made evaluation prior to staining more difficult, however, after staining the site and quantity of the contamination was evident (Figure 5). The visualized results revealed a reddish orange color in the areas of residual protein and amino acid contamination. All HAs except one showed at least one surface stained by the phloxine B and therefore contaminated (Table 2).

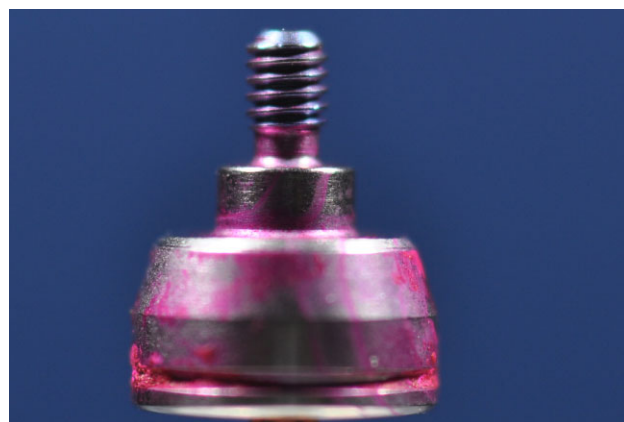
Figure 6 Implant healing abutments that contained circumferential grooves showed contamination within the site.

numbers involved are listed in Table 2. Some variation in the site of residual contaminant staining was noted but could not be further quantified due to the imbalance in sample size of abutment type. However, some generalizations could be made: It was noted that the Hiossen implants contained a groove circumferentially near the occlusal aspect of the body of the abutment which was consistently stained and would be expected to harbor debris as it is very improbable that this can be effectively cleaned (Figure 6).

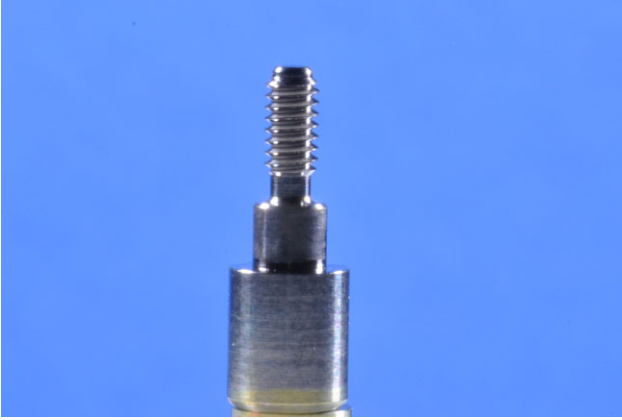
Figure 7 New healing abutment. Wiped, ultrasonic bath cleaned, sterilized, and stained with Phloxine B. No protein or peptide stained.
