**INTER-OFFICE COMMUNICATION
PALM BEACH COUNTY
FACILITIES DEVELOPMENT & OPERATIONS**

RE: Phase II Environmental Site Assessment
Lease Parcel N-11 and Pond Areas
1440 North Perimeter Road
West Palm Beach, Florida

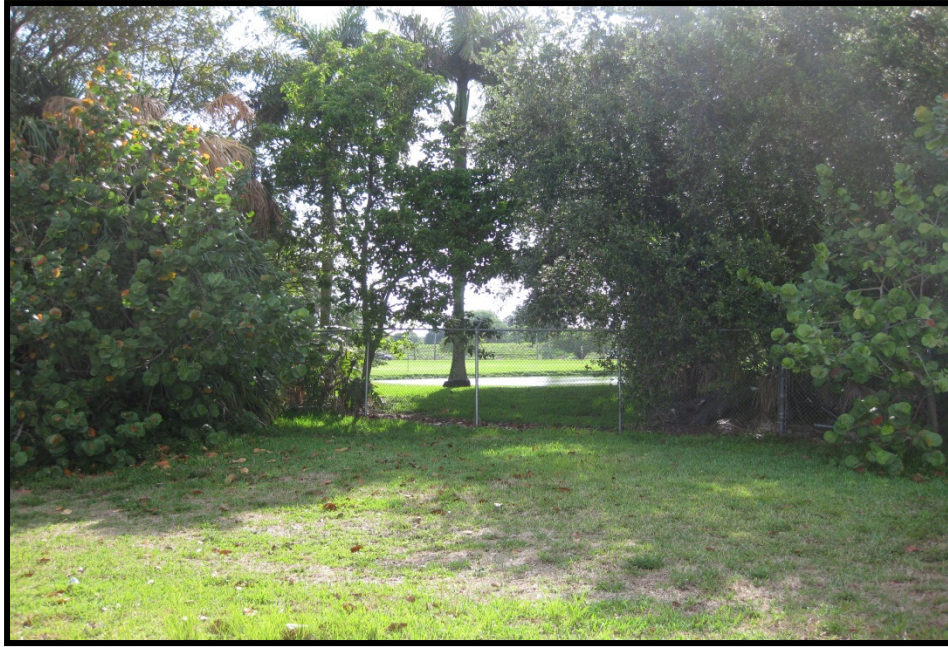
Photo: Lake located on the southeast portion of the Site followed by Australian Avenue (view east).

5. Since it is unknown if the entire landfill was excavated during construction of the lake in the southeast portion of the Site, URS recommends evaluating the west, north, and east sides of the man-made lake for the presence of potential buried material. URS recommends advancing trenches on the west, north, and east sides of the man-made lake. In the event bury solid waste is identified, the buried material should be documented and further delineated under a separate scope of work. Up to two soil samples should be collected and analyzed for petroleum constituents including PAHs and TRPHs, and for arsenic, cadmium, chromium, and lead. **The cost to advance trenches and collect soil samples is \$8,686.** The cost to advance soil boring and collect soil and groundwater samples is included in **Appendix L.**

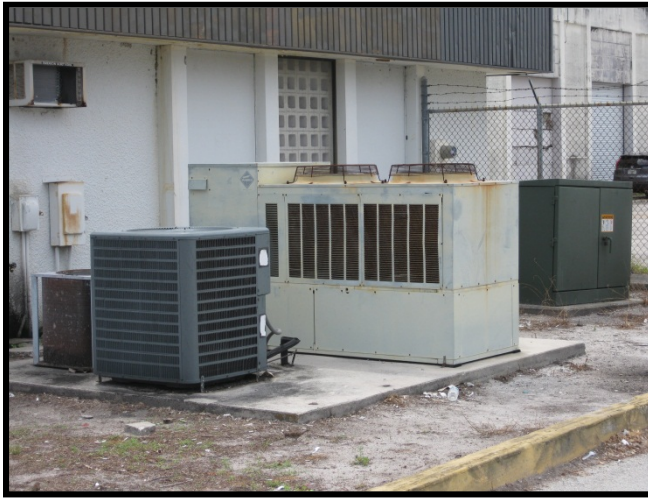
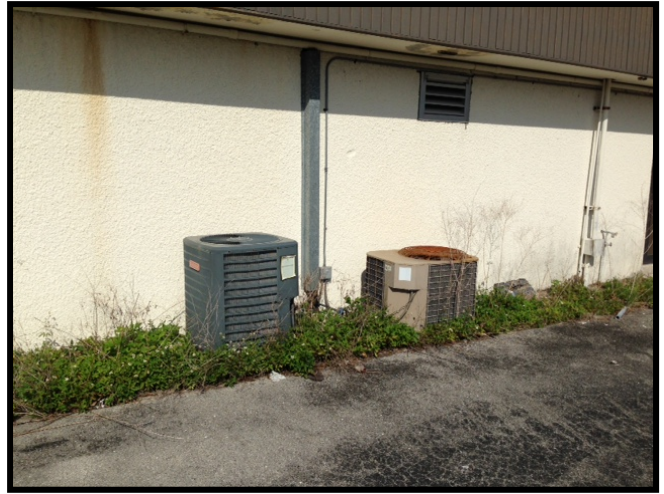
Three pad mounted air conditioning units and one window mounted air conditioning unit were observed on the west side of the office building. Two of the three air conditioning units were compressors and the third was a package unit. Two air conditioning units were observed on the east side of the office building adjacent to the electrical/pump room. One hot water heater was observed in one of the storage rooms in the southern portion of the office building. A small basin equipped with a drain was observed adjacent to the hot water heater.

Florida Power & Light Company supplies the Site and the surrounding area with electrical service. Two pole mounted transformers and one pad mounted transformer were observed at the Site. One pole mounted transformer was located immediately north of the office building. The second pole mounted transformer was observed on the west side of the cell phone parking lot on the east side of North Perimeter Road. The pad mounted transformer was located immediately west of the office building. One set of power lines were observed on the western boundary of the site and a second set was observed bisecting the waiting area parking lot. These two sets of power lines were installed in a north/south direction. A third set was observed heading from North Perimeter Road eastward towards the office building.

The pole mounted and pad mounted transformers appeared to be in good condition. No evidence of dead or stressed vegetation was observed below the transformers.

Photo: Four air conditioning units and a pad mounted transformer are located on the west side of the office building. Two additional air conditioning units are located on the east side of the office building near a former pump room.

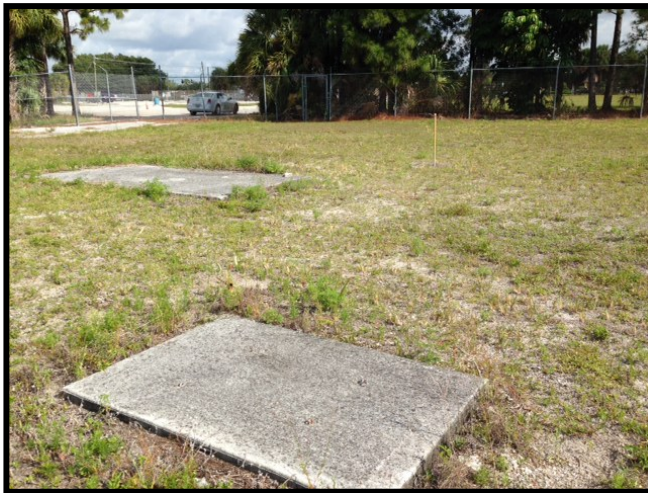
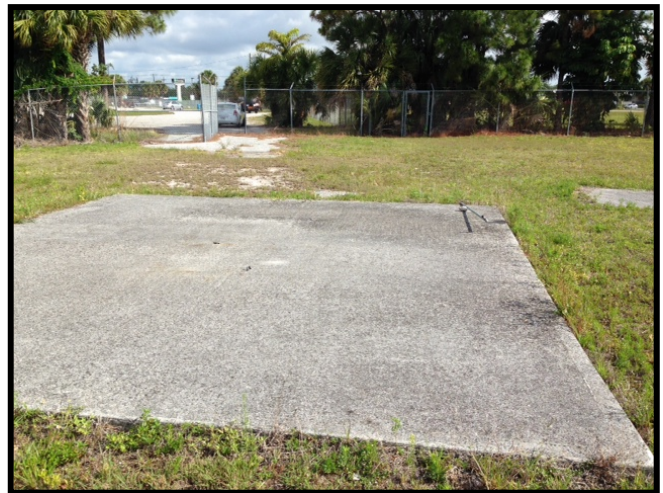
Three concrete pads and a sidewalk were observed in the northeast portion of the Site. The concrete pads were located in a grassy area east of the maintenance garage. Metal conduit was observed adjacent to two of the three concrete pads. The purpose of the metal conduit could not be determined.

Photo: Concrete pads located east of the maintenance area garage. Metal conduit was observed adjacent to the pads.

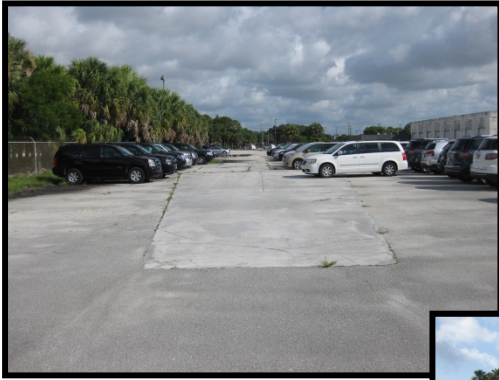
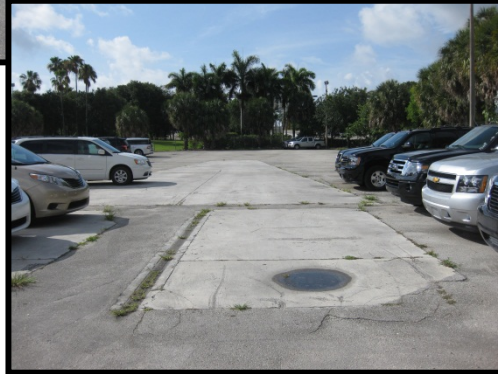
Photo: Former bus wash area located in the southwest portion of the Site.

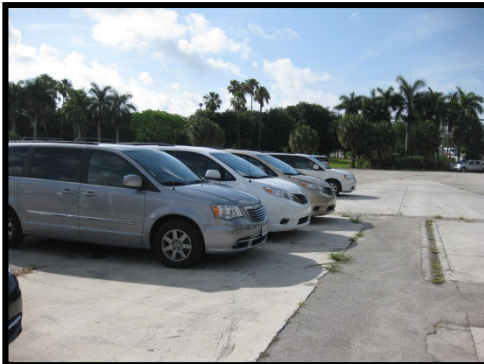
Former
UST
Area

Photo: Former AST and UST areas located immediately north of the former bus washing area. Former product transfer lines transferred new oil and automatic transmission fluid to the island from a pump room located on the east side of the office area.

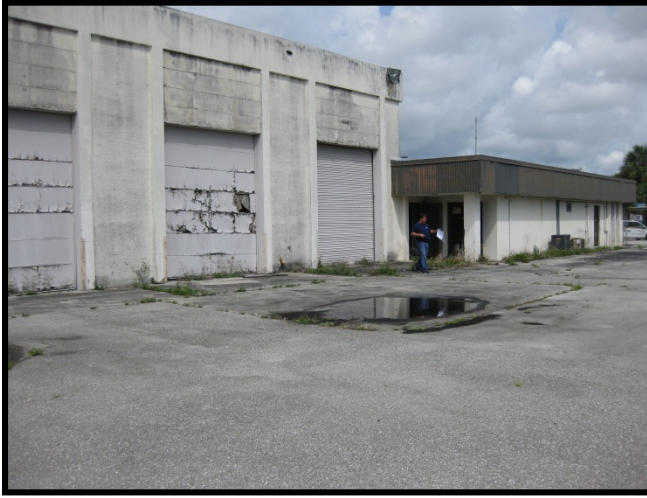
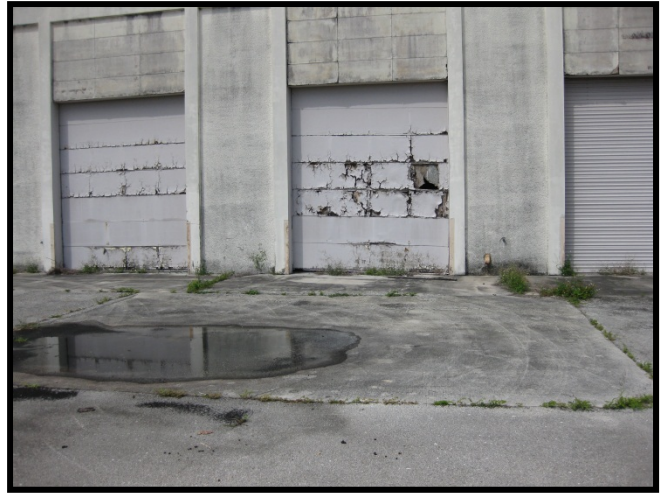
Photo: Location of former new and used oil USTs and an automatic transmission fluid UST located on the east side of the maintenance area garage.

3. Since there were no confirmation soil or groundwater samples following the removal of the USTs on the east side of the maintenance area garage, URS recommends evaluating the soil and groundwater quality in the vicinity of the former USTs. URS recommends advancing up to 10 soils borings in the vicinity of the former USTs. Soil samples from the boring locations should be screened for petroleum vapors with an OVA or screened with a Petro-Flag. Based on the OVA/Petro-Flag results, up to four soil samples and two groundwater samples should be collected and analyzed for petroleum constituents including BTEX and MTBE, PAHs, TRPHs, and for arsenic, cadmium, chromium, and lead. **The cost to advance the soil borings/groundwater well points and collect soil and groundwater samples is \$13,062.** The cost to advance soil boring and collect soil and groundwater samples is included in **Appendix L.**

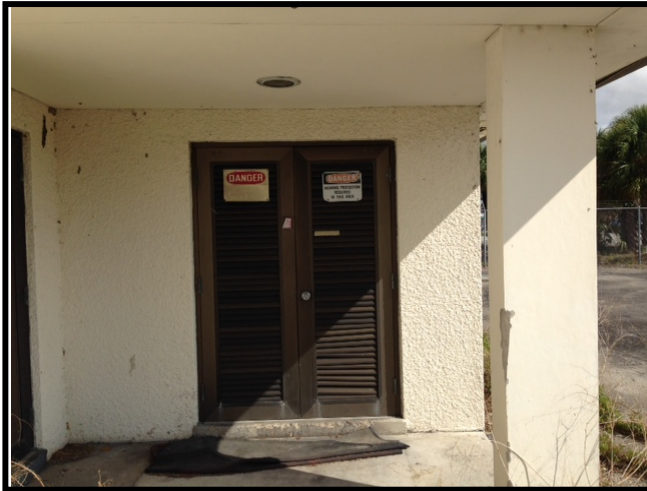
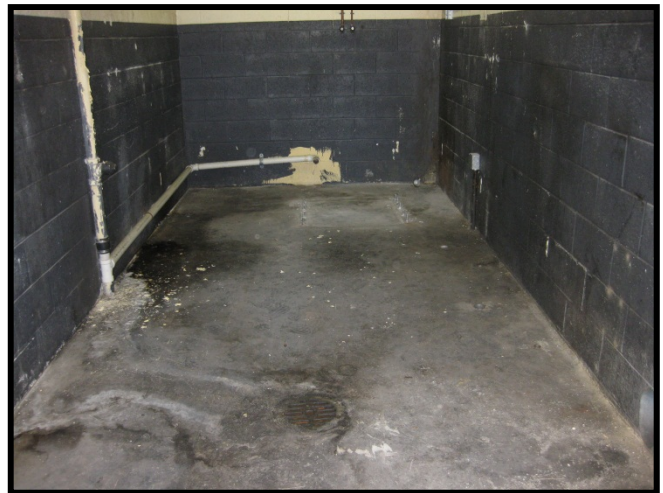
Photo: New oil and automatic transmission fluid were transferred to the fuel island via underground product piping from a pump room located on the east side of the office building.

4. Since it is unknown if the former oil and ATF transfer lines to the pump room were removed and there is no confirmation soil or groundwater samples, URS recommends evaluating the presence of the transfer lines, as well as soil and groundwater quality in the

vicinity of the transfer lines. URS recommends advancing up to 10 soils borings in the vicinity of the transfer lines. Soil samples from the boring locations should be screened for petroleum vapors with an OVA or screened with a Petro-Flag. Based on the OVA/Petro-Flag results, up to three soil samples and two groundwater samples should be collected and analyzed for petroleum constituents including BTEX and MTBE, PAHs, TRPHs, and for arsenic, cadmium, chromium, and lead. **The cost for soil borings/groundwater well points and collect soil and groundwater samples is \$11,632.** The cost to advance soil boring and collect soil and groundwater samples is included in **Appendix L.**

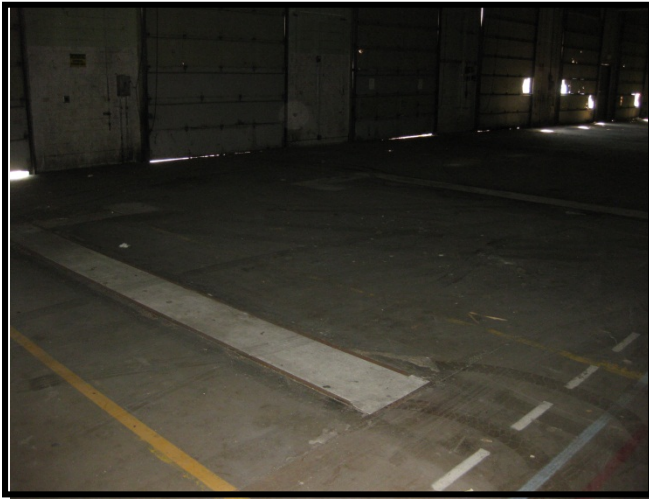
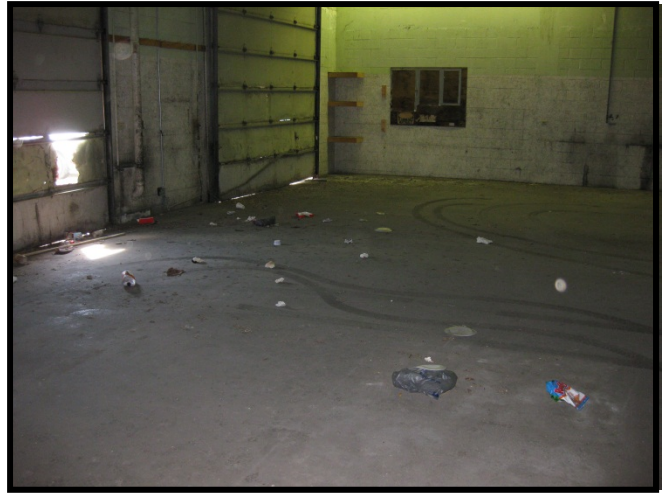
Photo: Two former hydraulic lifts were located in the maintenance area garage.

1. Since there were no confirmation soil or groundwater samples following the hydraulic lift removal, URS recommends evaluating the soil and groundwater quality in the vicinity of the former hydraulic lifts. URS recommends advancing up to 10 soils borings in the vicinity of the former hydraulic lifts. Soil samples from the boring locations should be screened for petroleum vapors with an OVA or screened with a Petro-Flag. Based on the OVA/Petro-Flag results, up to three soil samples and two groundwater samples should be collected and analyzed for petroleum constituents including polynuclear aromatic hydrocarbons, (PAHs), TRPHs, and for cadmium, chromium, and lead. **The cost to advance the soil borings/groundwater well points and collect soil and groundwater samples is \$11,546.** The cost to advance soil boring and collect soil and groundwater samples is included in **Appendix L.**

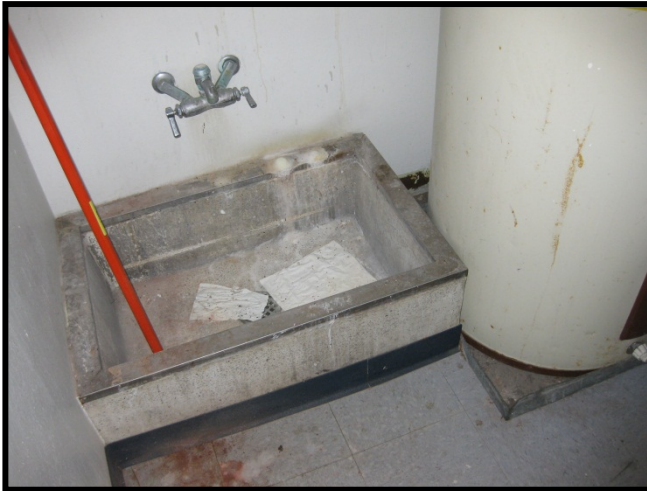
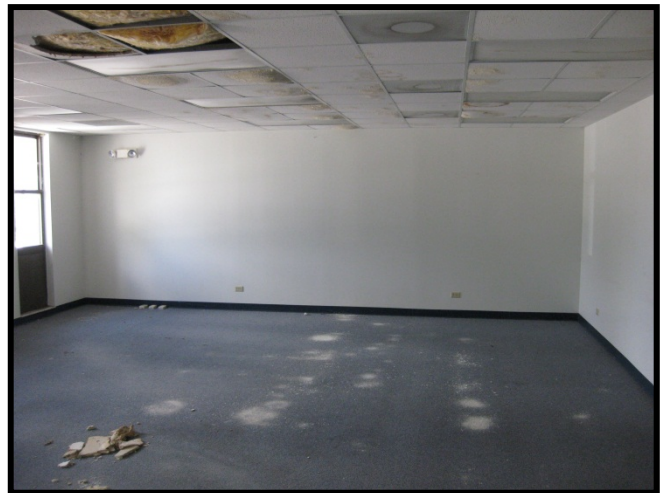
Photo: Hot water heater and floor drain in one office building storage closet and a typical office room.
